ADVANCED COMPOSITE ELEVATOR FOR BOEING 727 AIRCRAFT VOLUME 2—FINAL REPORT

Boeing Commercial Airplane Company
P.O. Box 3707, Seattle, WA 98124

CONTRACT NAS1-14952
NOVEMBER 1980

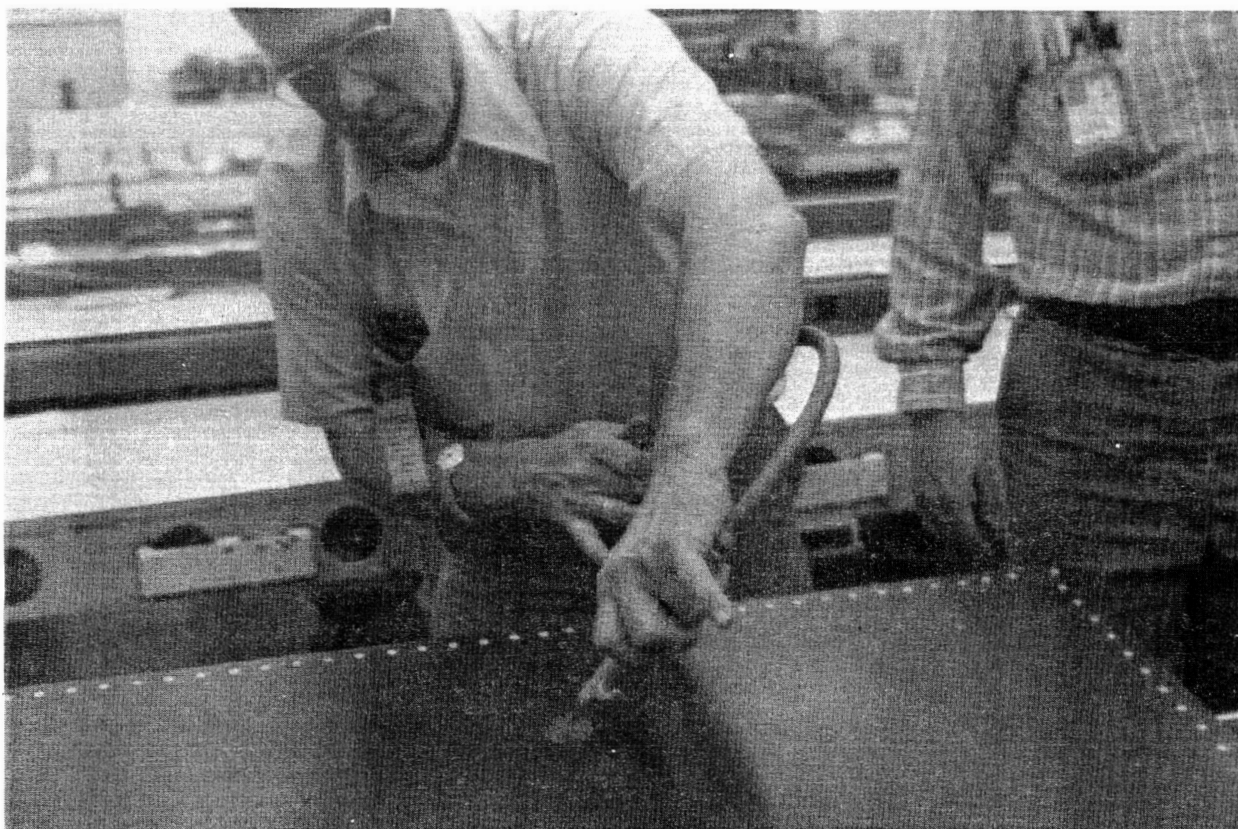
Figure A1.4. Removal of Damaged Core

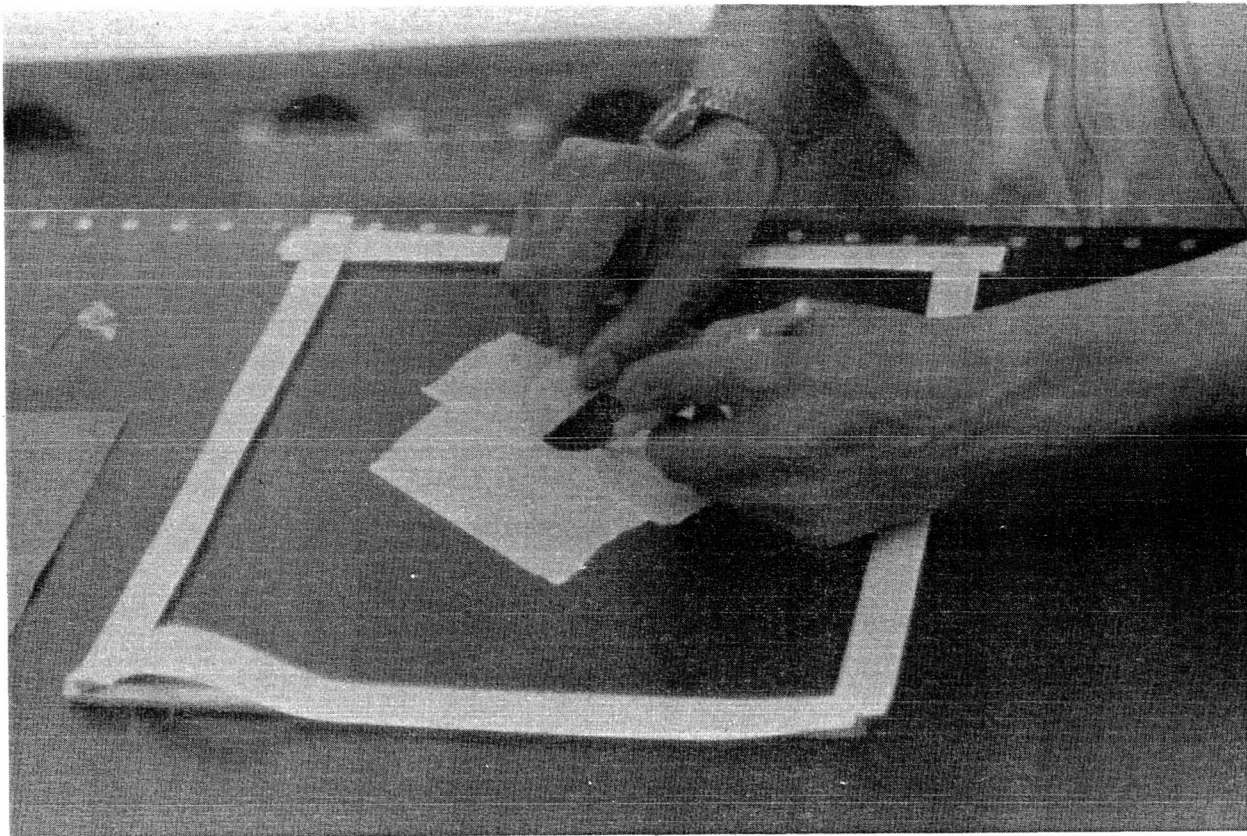
Figure A1.5. Masking of Repair Area

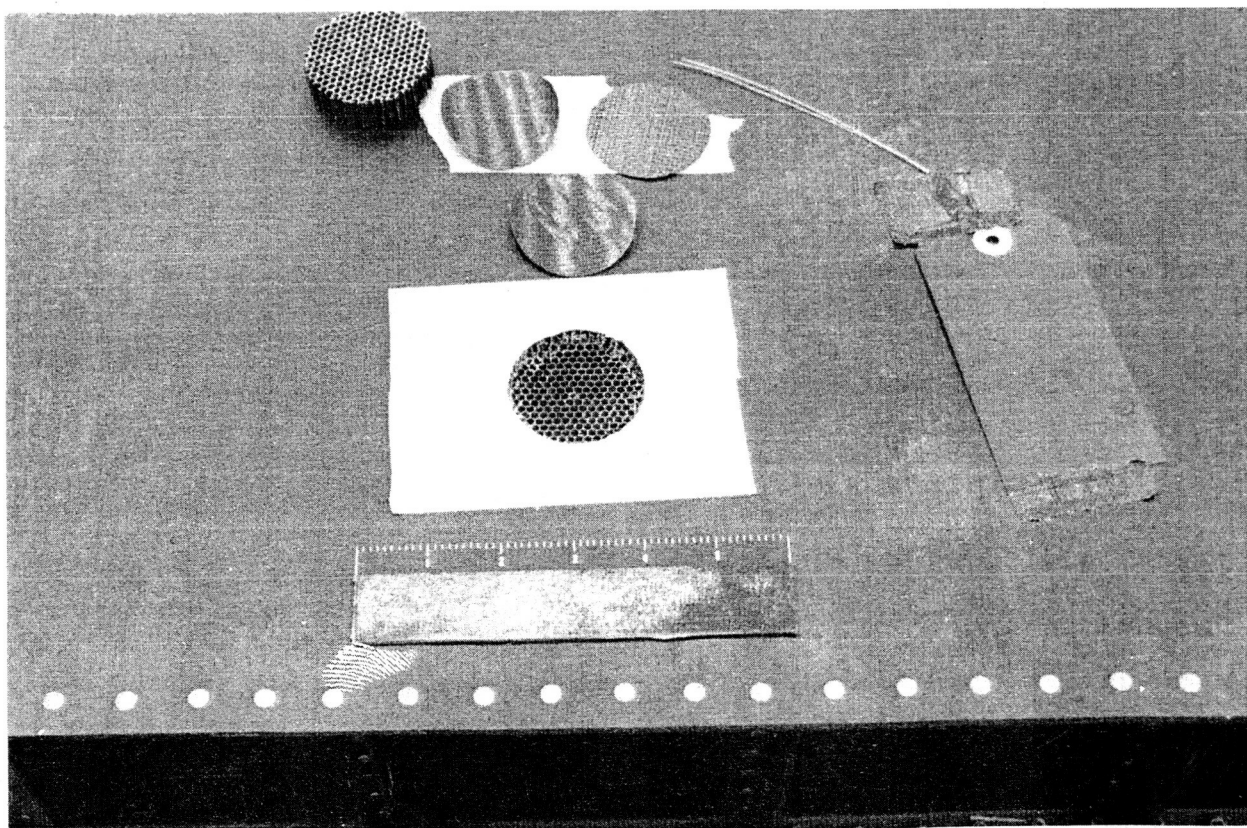
Figure A1.6. Core Replacement and Adhesive Ready for Installation

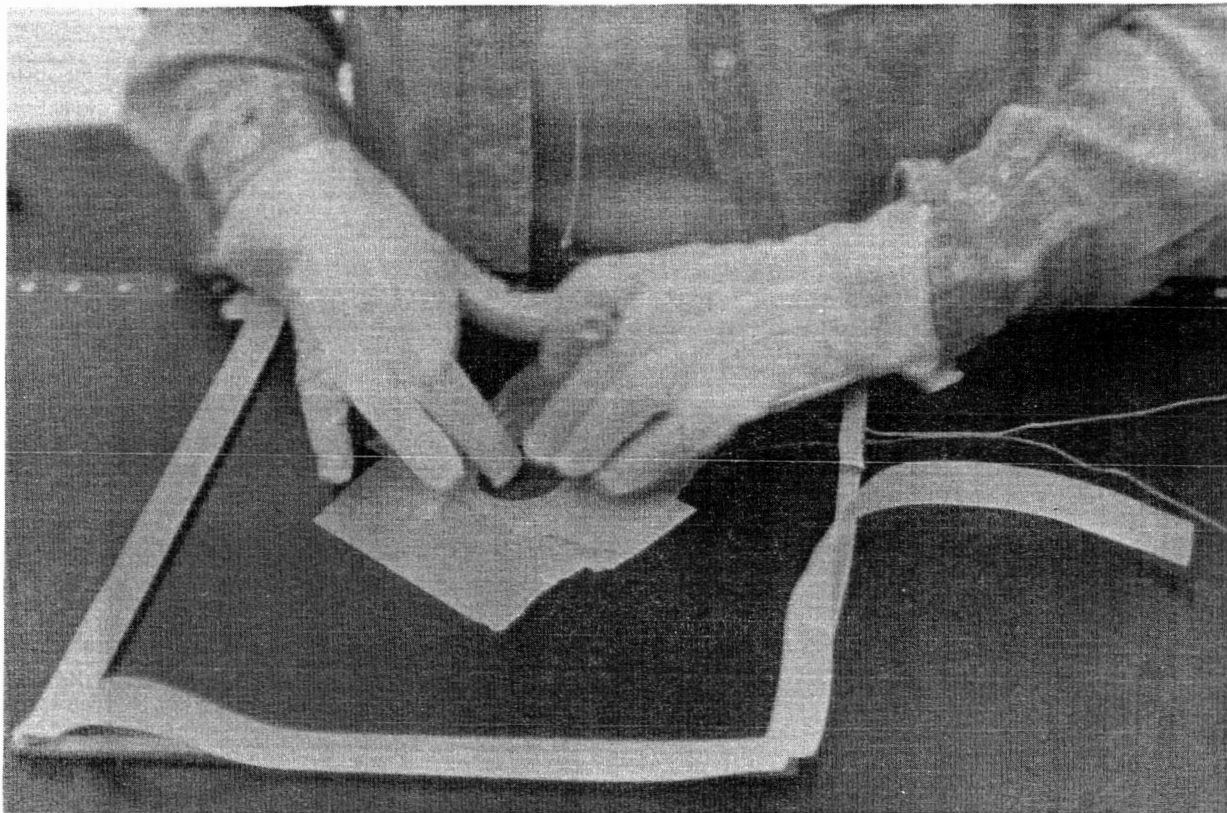
Figure A1.7. Installation of Adhesive

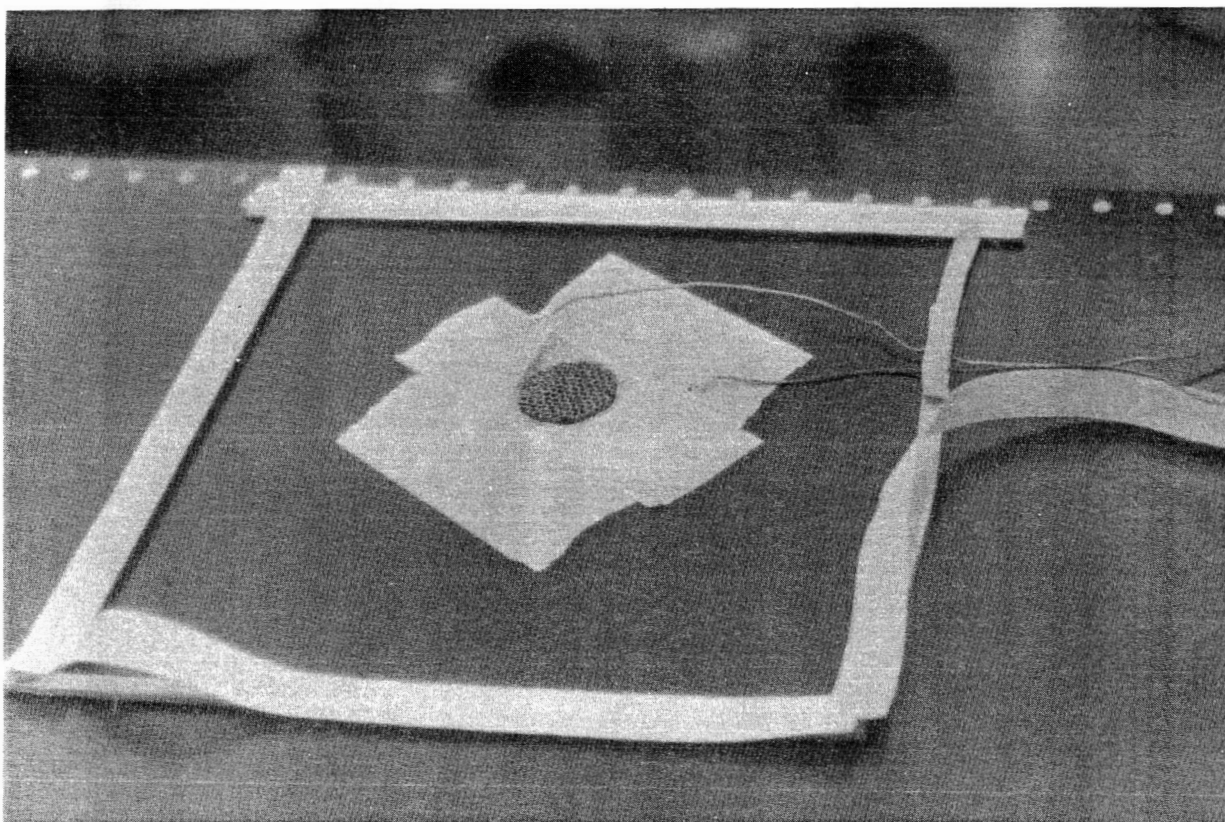
Figure A1.8. Core Replacement in Place

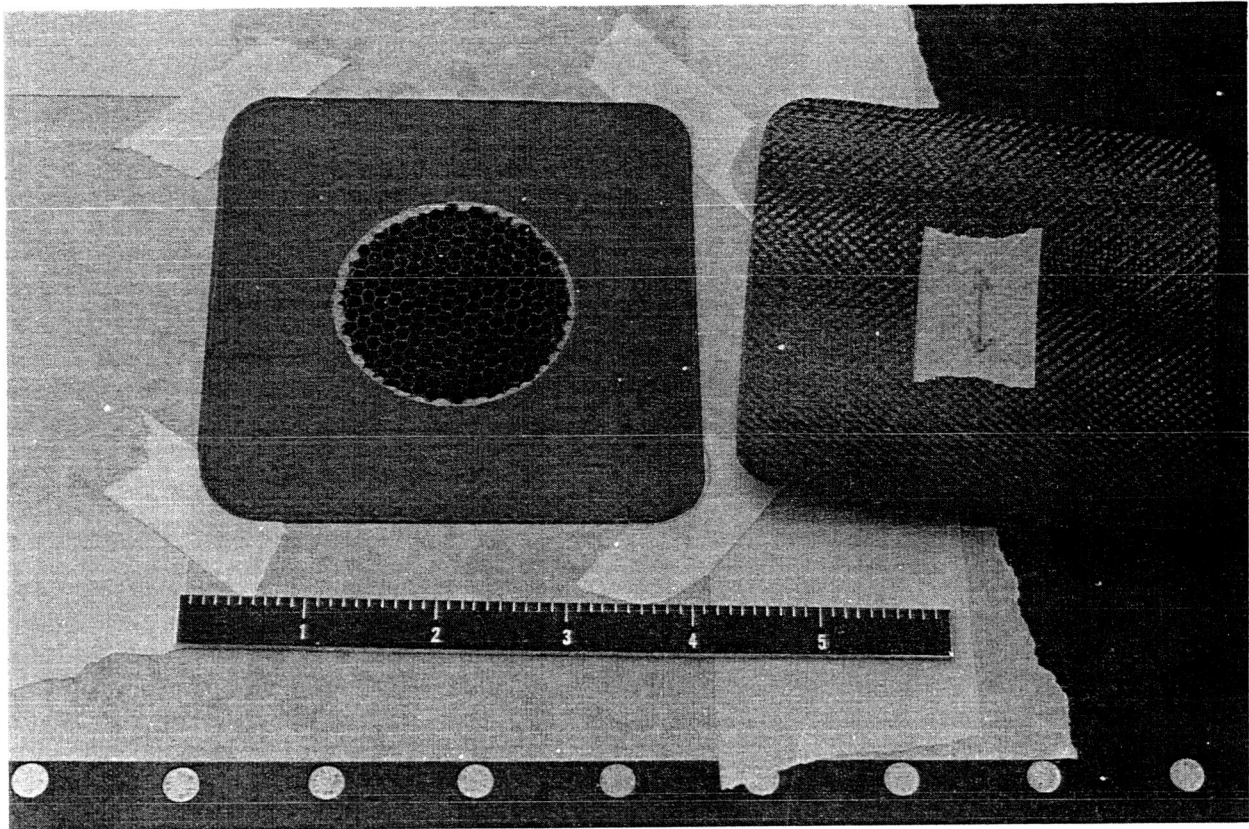
Figure A1.9. Core Replacement after Installation With Precured Patch Ready for Installation

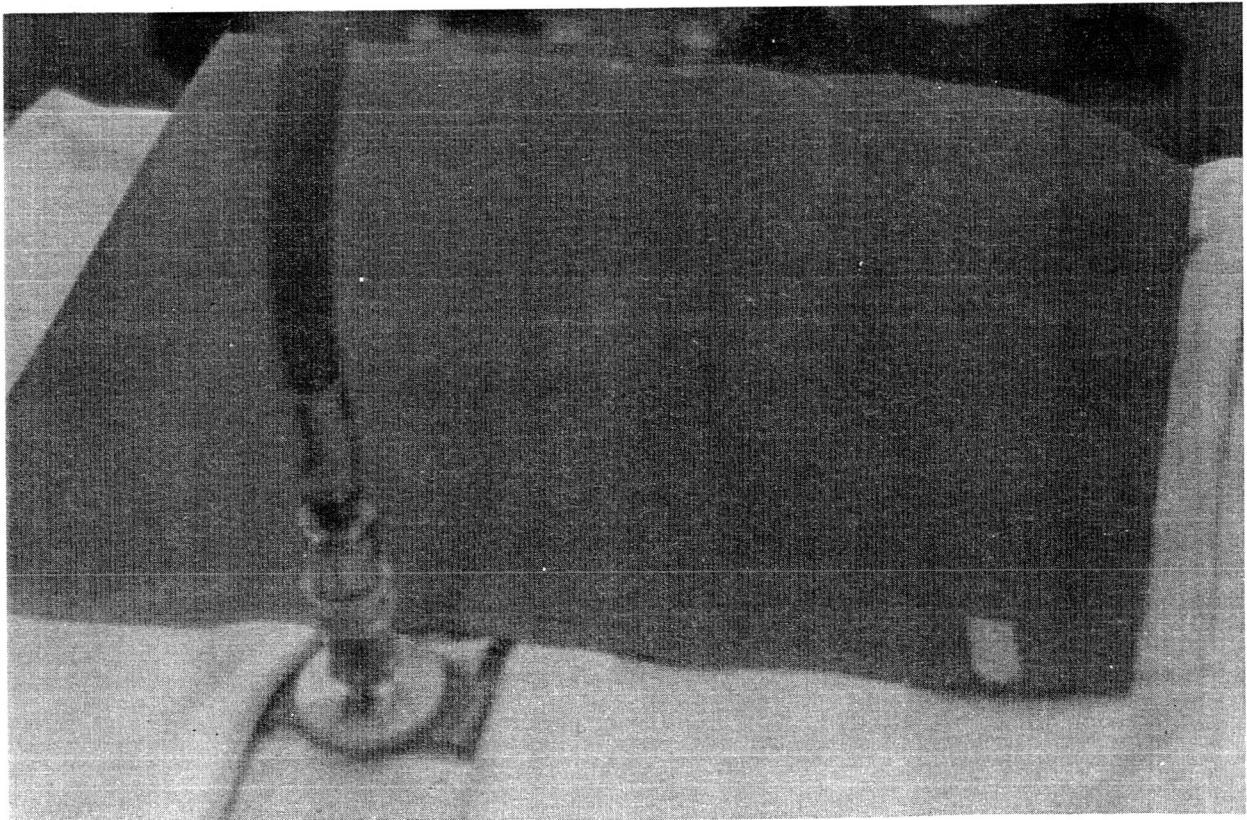
Figure A1.10. Heating Pad in Place

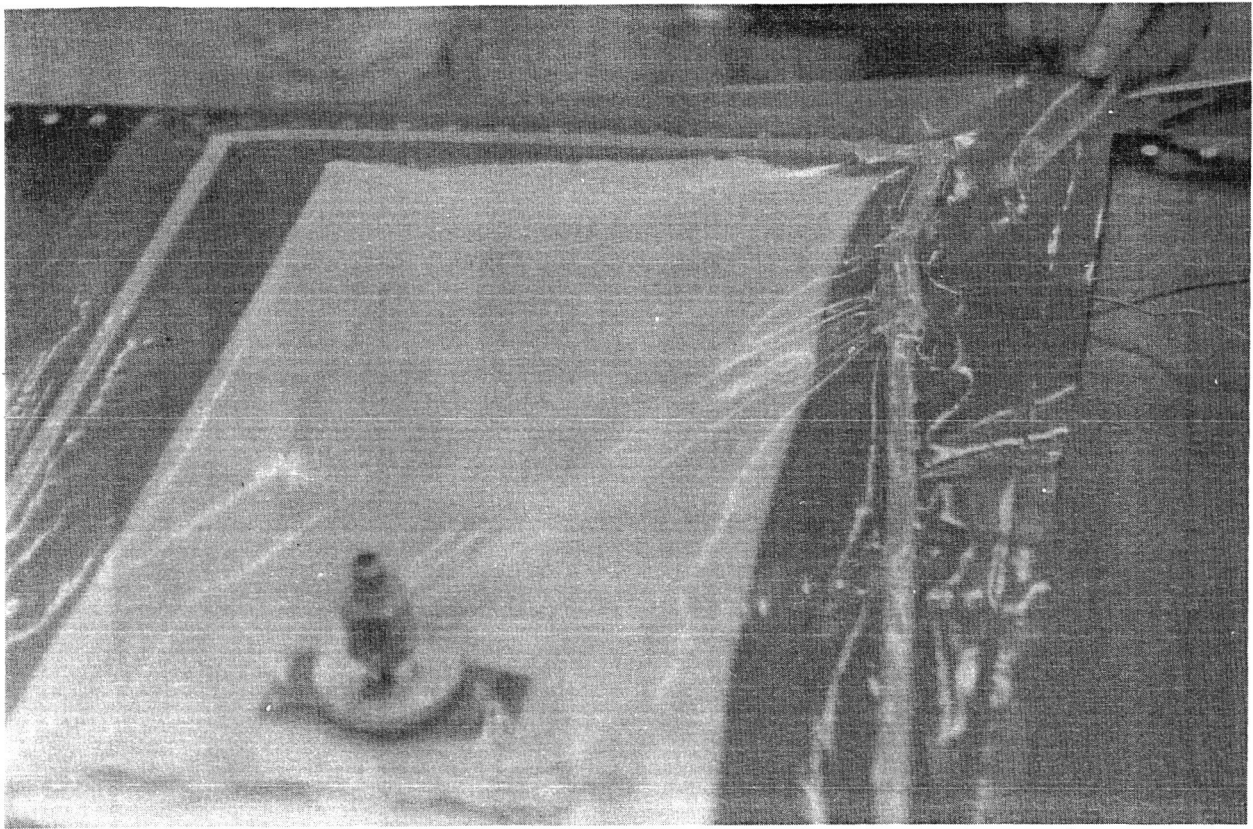
Figure A1.11. Vacuum Bag in Place

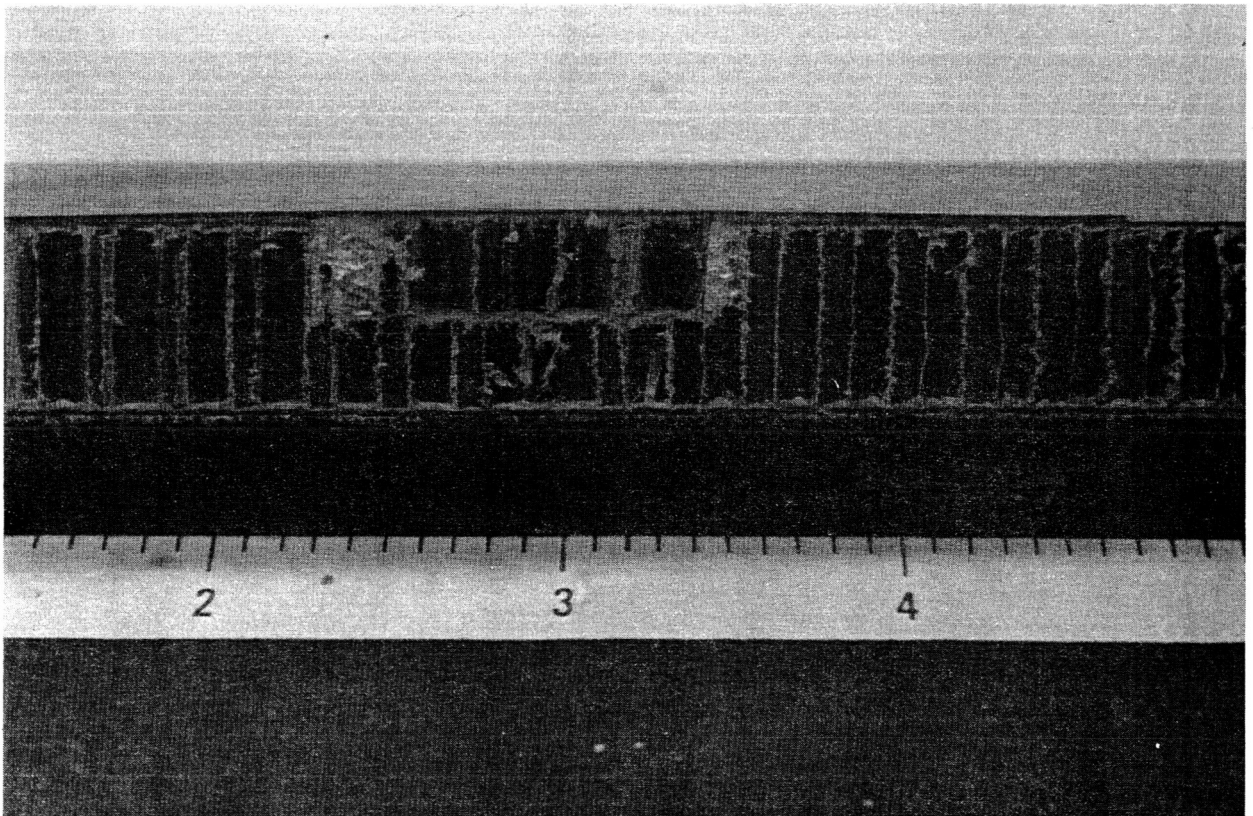
Figure A1.12. Cross-Section Through Repaired Panel

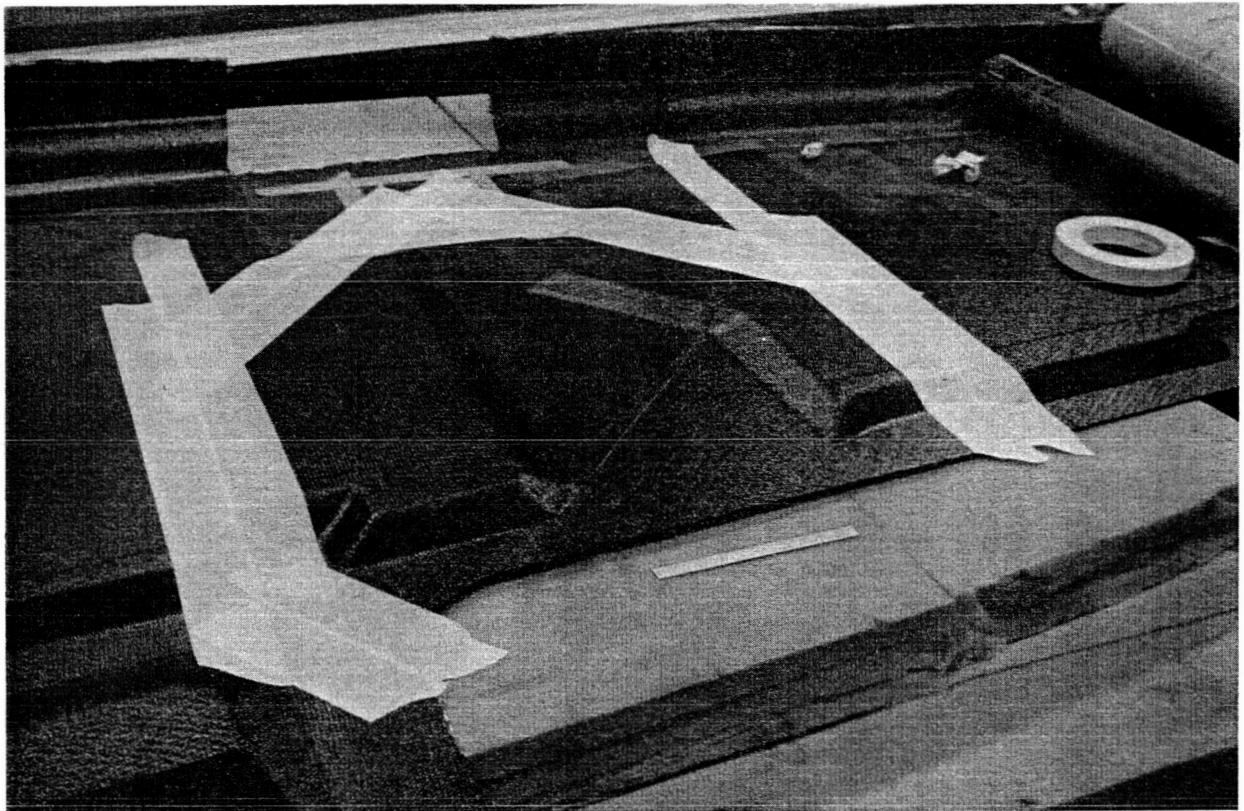
Figure A1.13. Graphite/Epoxy Sandwich Panel Core Repair—Repair Area Masked

Figures A1.13 through A1.20 show some of the major steps of repairing core which was mislocated during fabrication of a graphite/epoxy sandwich panel. The graphite plies used in the repair were impregnated with epoxy resin and the repair was cured in an autoclave.

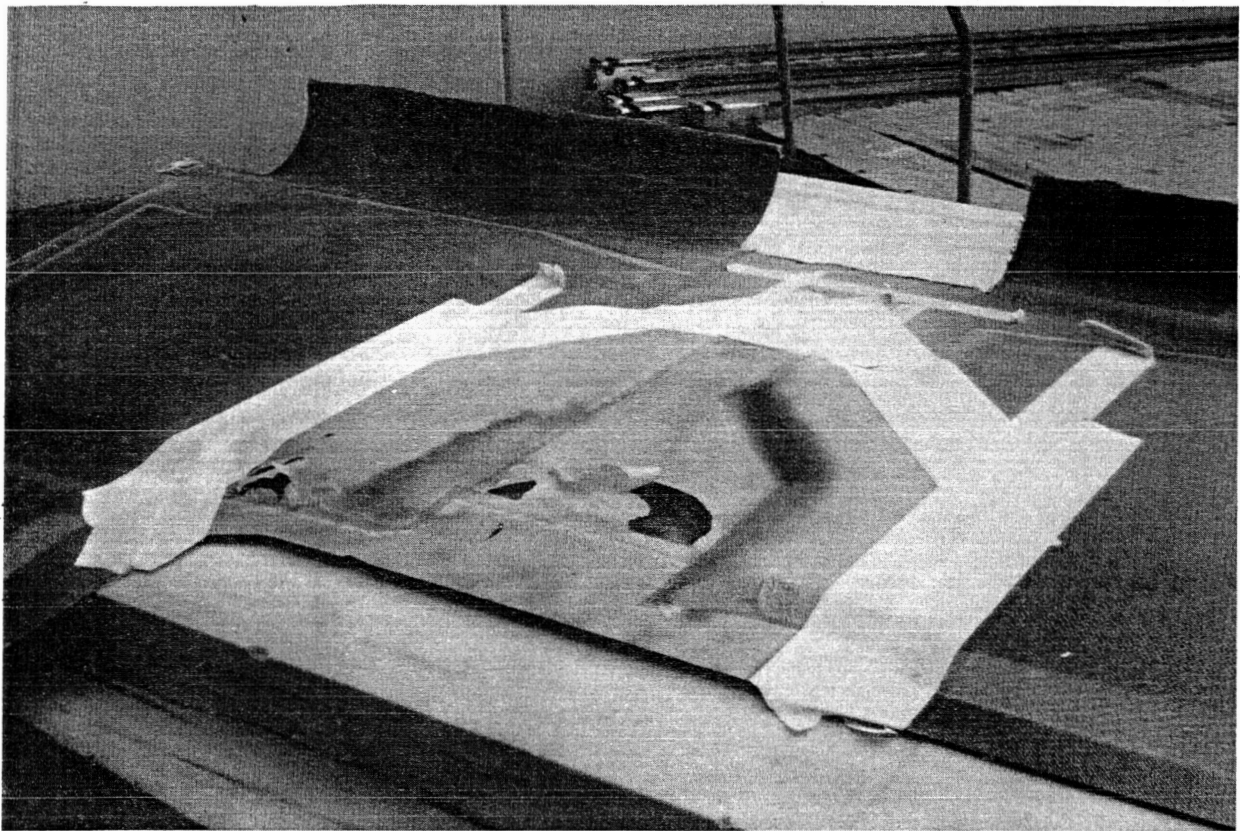
Figure A1.14. Graphite/Epoxy Sandwich Panel Core Repair—Grit Blasting of Tedlar Surface

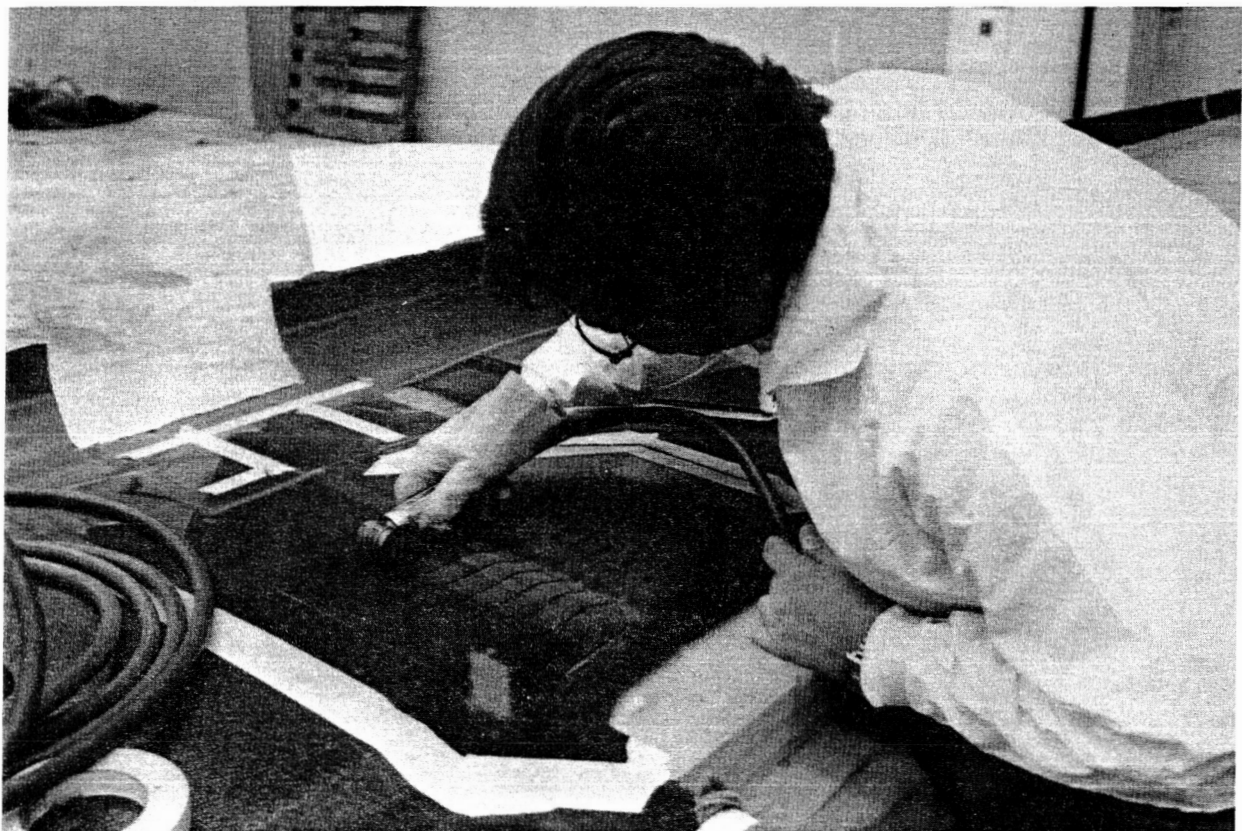
Figure A1.15. Graphite/Epoxy Sandwich Panel Core Repair—Tedlar After Grit Blasting

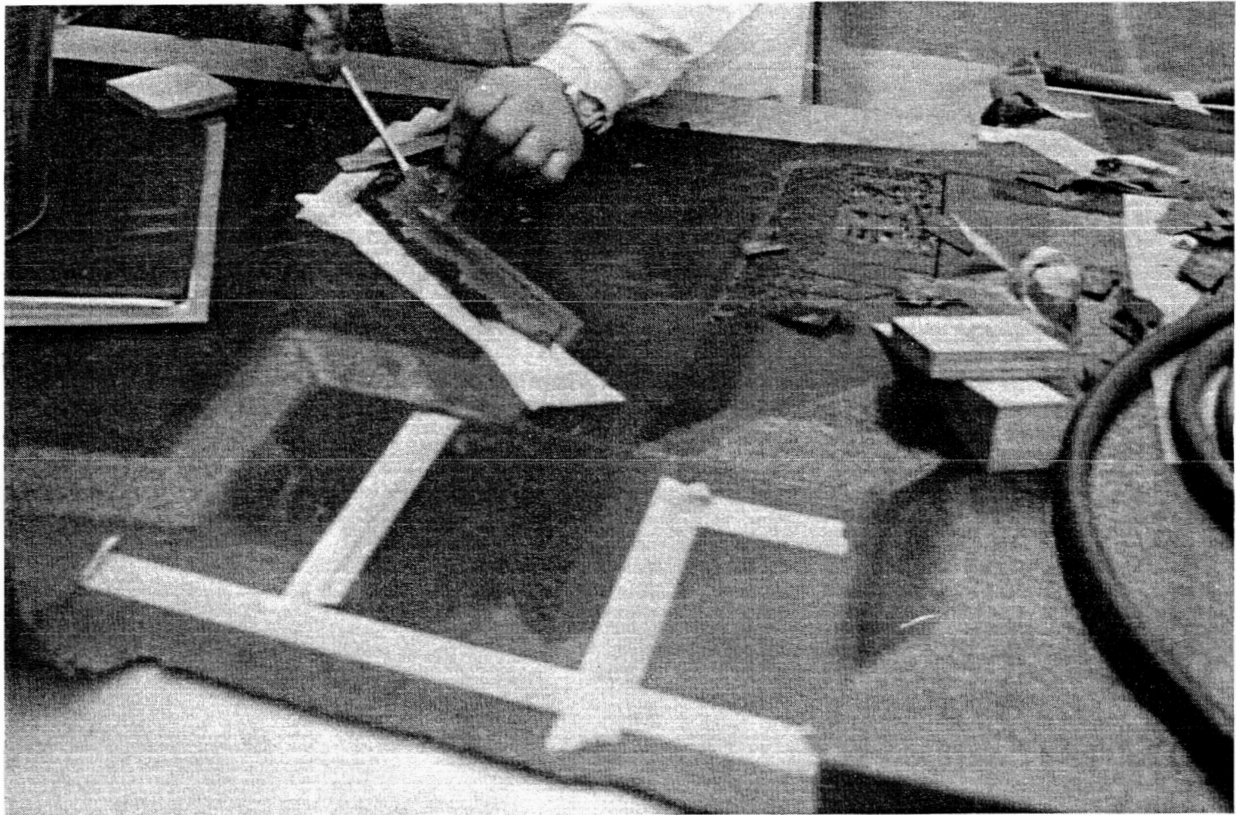
Figure A1.16. Graphite/Epoxy Sandwich Panel Core Repair—Removal of B-61

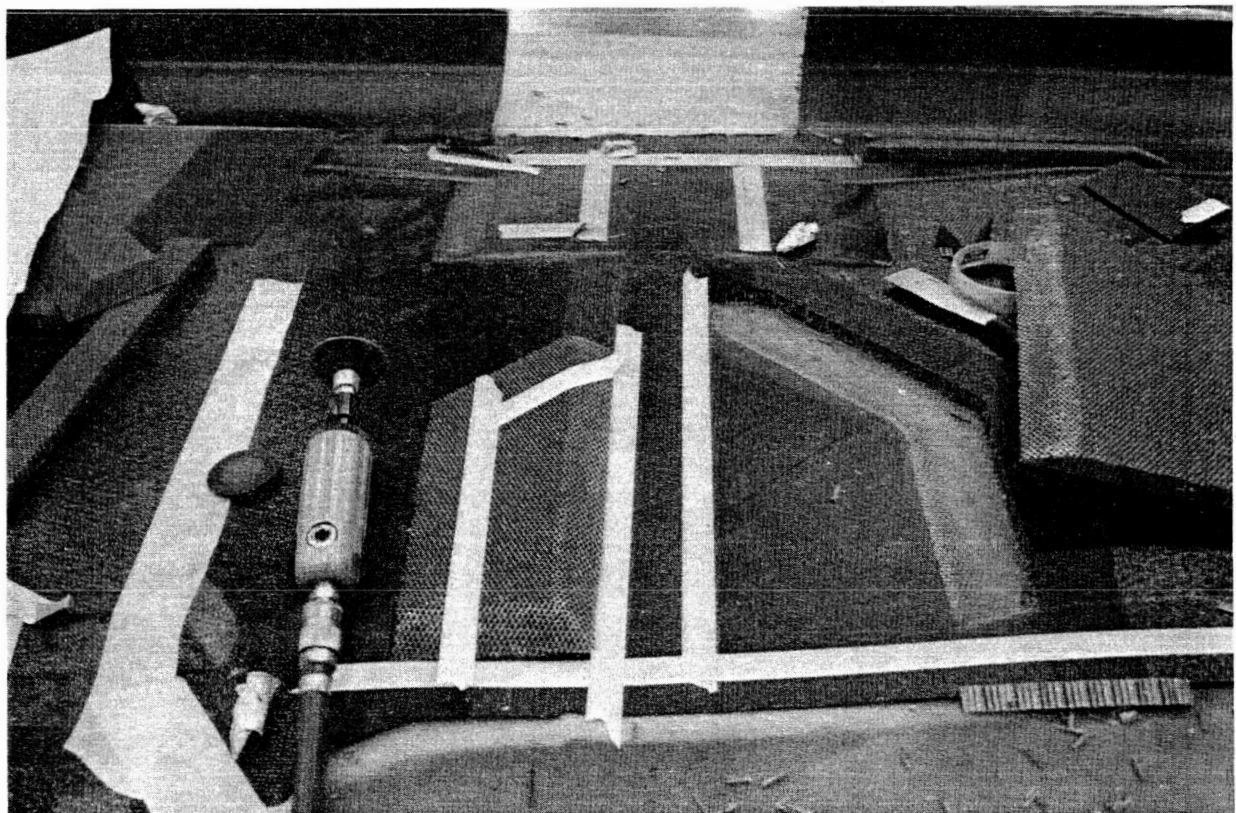
Figure A1.17. Graphite/Epoxy Sandwich Panel Core Repair—Removal of Damaged Core

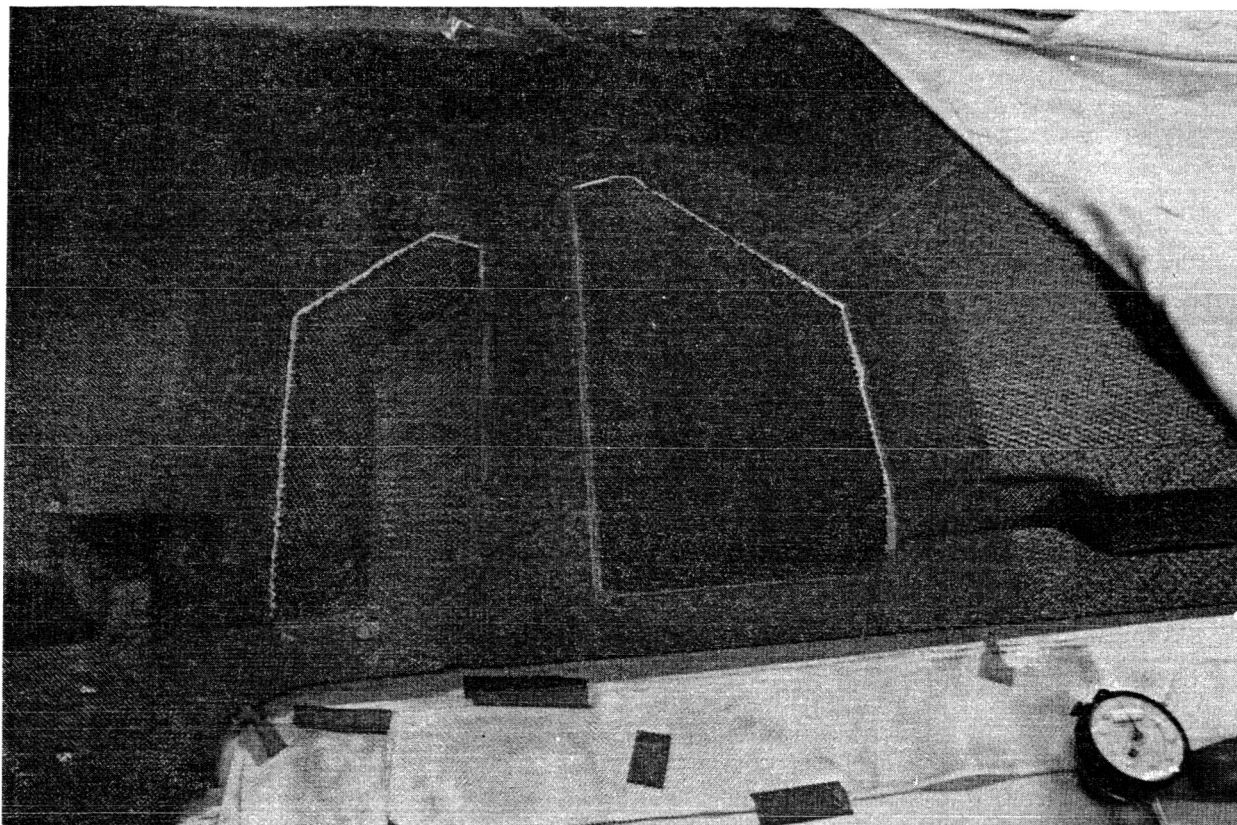
Figure A1.18. Graphite/Epoxy Sandwich Panel Core Repair—Replacement Core in Position (Left) and Core Ready for Installation (Right)

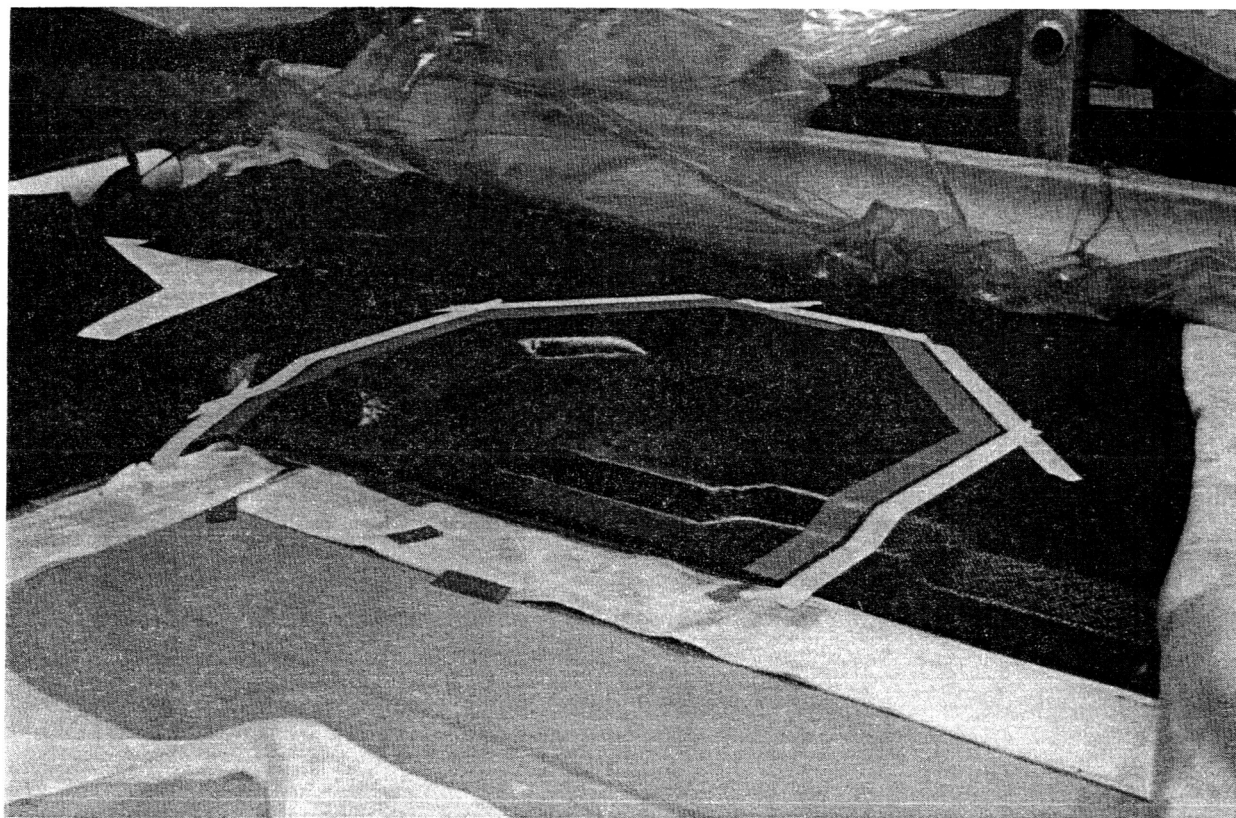
Figure A1.19. Graphite/Epoxy Sandwich Panel Core Repair—Replacement Core Bonded to Panel

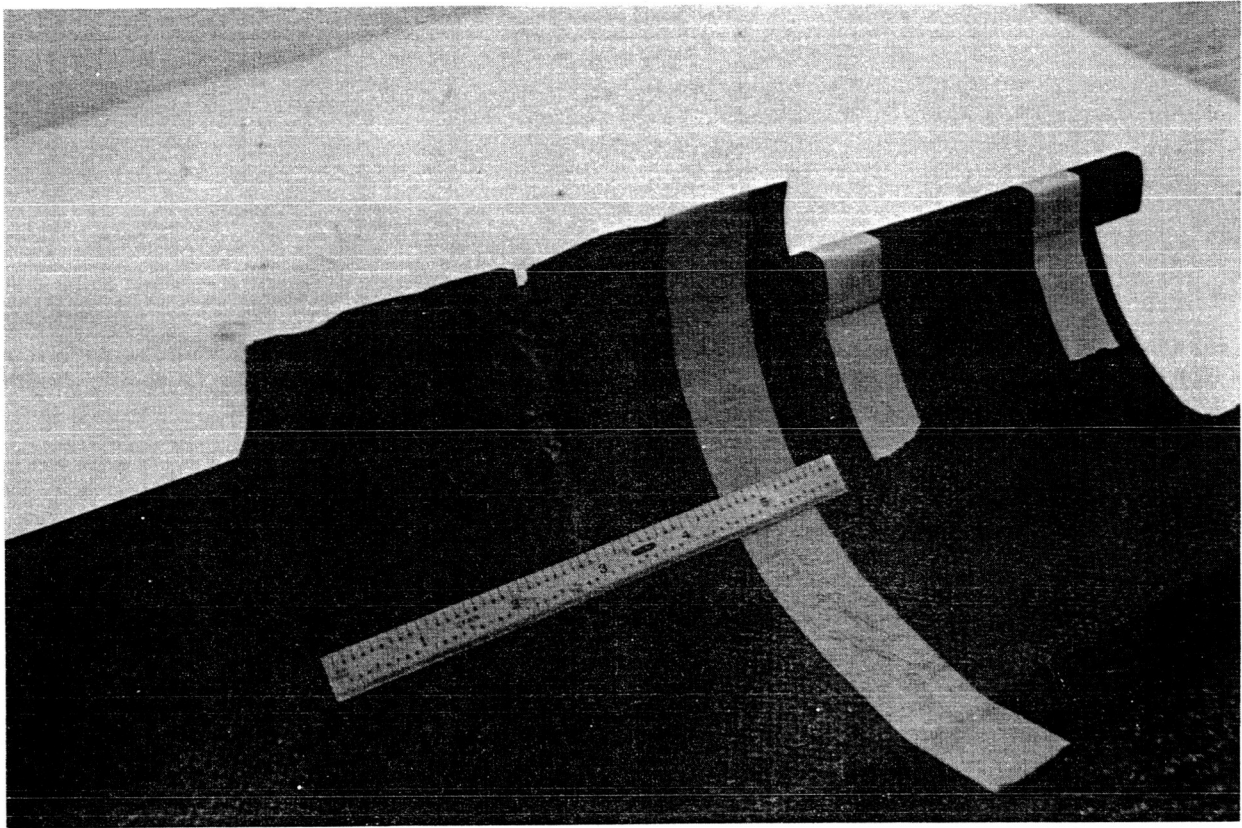
Figure A1.20. Graphite/Epoxy Sandwich Panel Core Repair—Replacement Graphite Plies After Curing

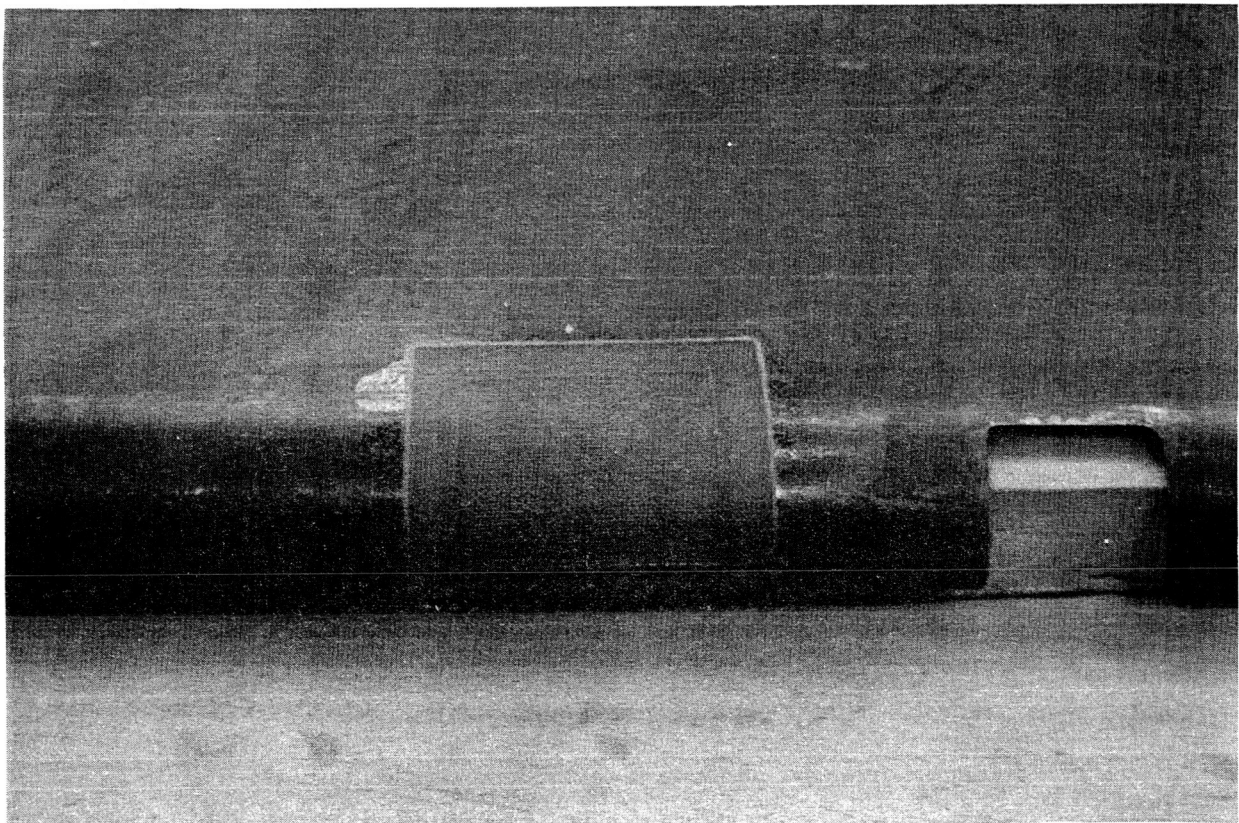
Figure A1.21. Crack in Solid Graphite/Epoxy Laminate Before Repair

The graphite/epoxy component shown in Figures A1.21 and A1.22 was cracked in a solid laminate area during fabrication. These two figures depict the crack before and after repair.

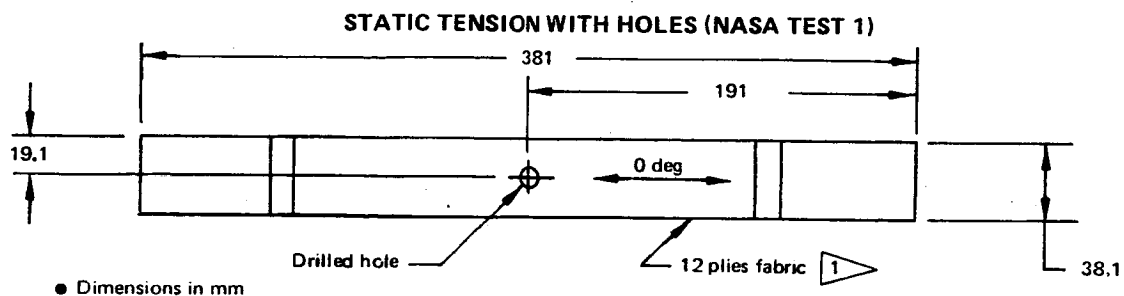
Drawing and assembly no. 2	Cloth warp orien- tation, deg 3	Test tem- per- ature °C	Environment condition 4		Actual hole dia- meter, mm	Speci- men width, mm	Speci- men nominal thick- ness, mm	Failure load, kN 5	Failure stress, MPa 6	E, MPa 7	Strain, ϵ , mm/mm 8
			Wet	Dry							
65C17702-1	±45	21.1		✓	7.95	38.28	2.286	12.944	147.93	2.069 × 10 ⁴	0.00715
				✓	7.98	38.15		13.255	152.00		0.00735

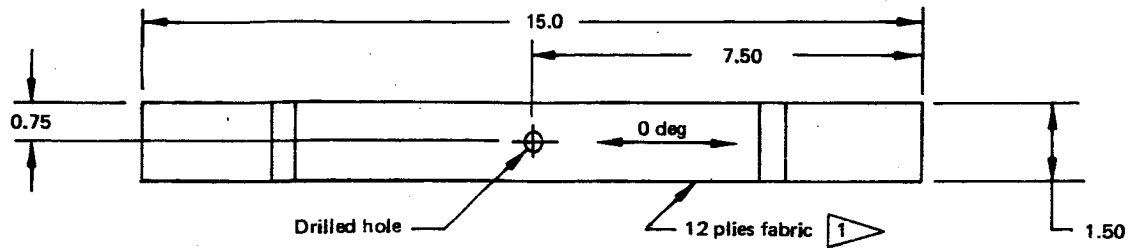
STATIC TENSION WITH HOLES (NASA TEST 1) (CONTINUED)

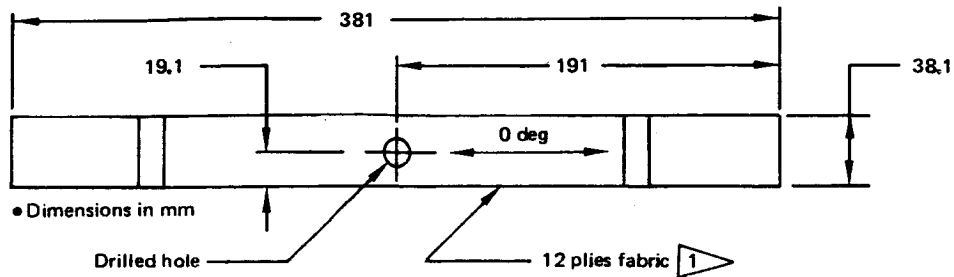
STATIC COMPRESSION WITH HOLES (NASA TEST 1)

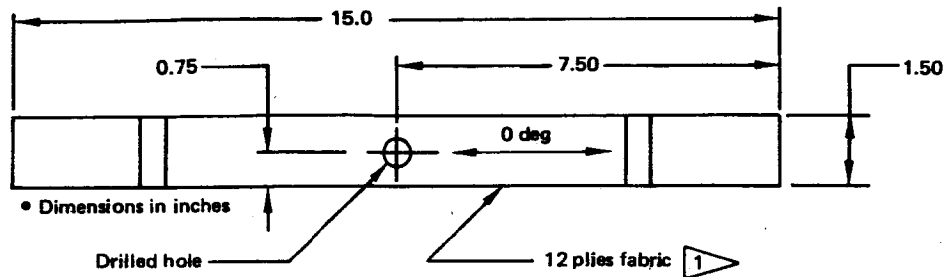
STATIC COMPRESSION WITH HOLES (NASA TEST 1) (CONTINUED)

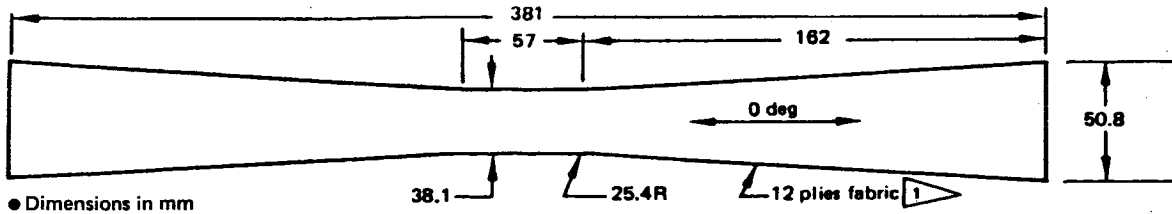
STATIC TENSION (BOEING 7313-16)

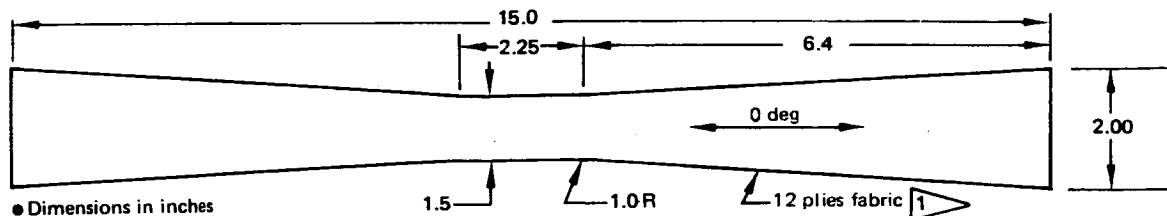
STATIC TENSION (BOEING 7313-16) (CONTINUED)

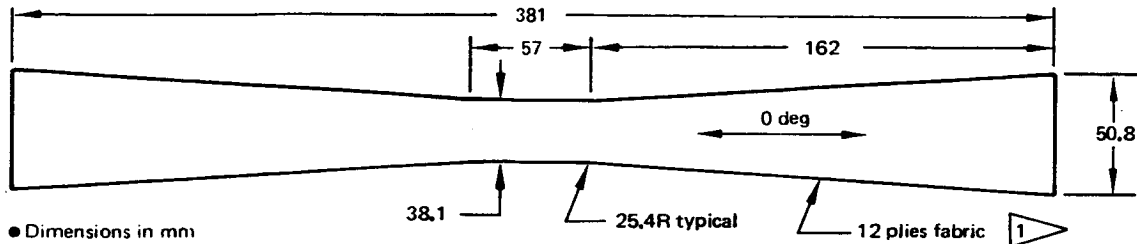
STATIC COMPRESSION (BOEING 7313-16)

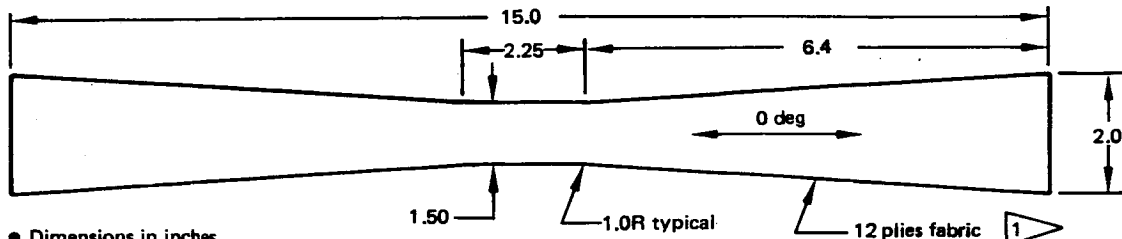
STATIC COMPRESSION (BOEING 7313-16) (CONTINUED)

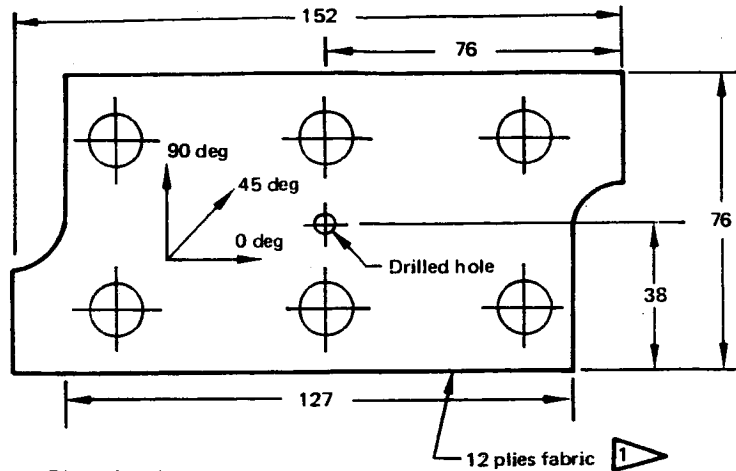
RAIL SHEAR WITH HOLES (NASA TEST 1)

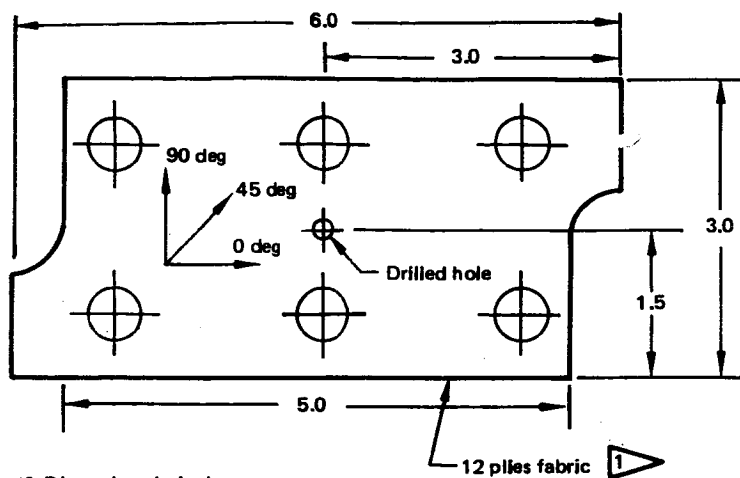
RAIL SHEAR WITH HOLES (NASA TEST 1) (CONTINUED)

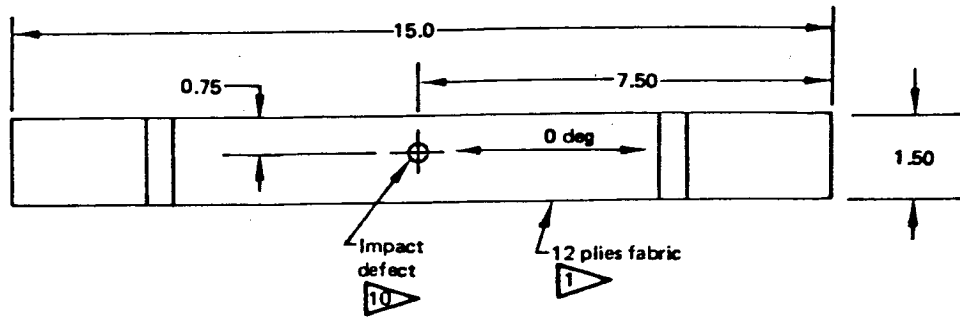
STATIC COMPRESSION WITH IMPACT (NASA TEST 1) (CONTINUED)

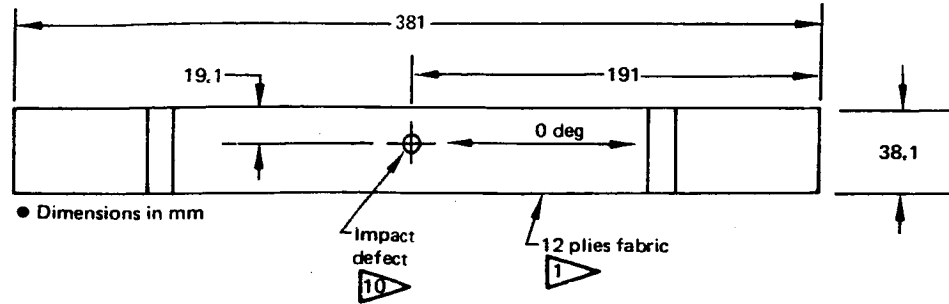
STATIC COMPRESSION WITH IMPACT (NASA TEST 1)

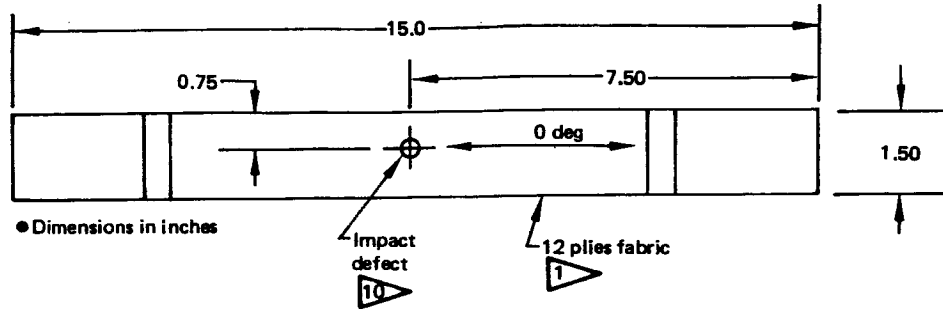
STATIC COMPRESSION WITH IMPACT (NASA TEST 1) (CONTINUED)

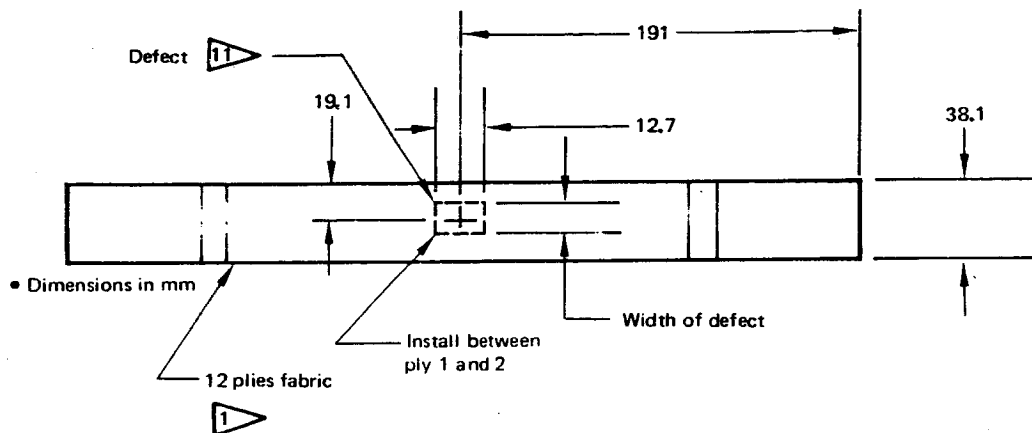
STATIC COMPRESSION WITH DELAMINATION (NASA TEST 1)
